FACILITY COMPLIANCE INSPECTION REPORT

Division of Waste Management Solid Waste Section

Carolina Resource Recovery, Inc. Treatment and Processing Facility
Jones Drive
Mebane, NC 27302

Comprehensive Inspection

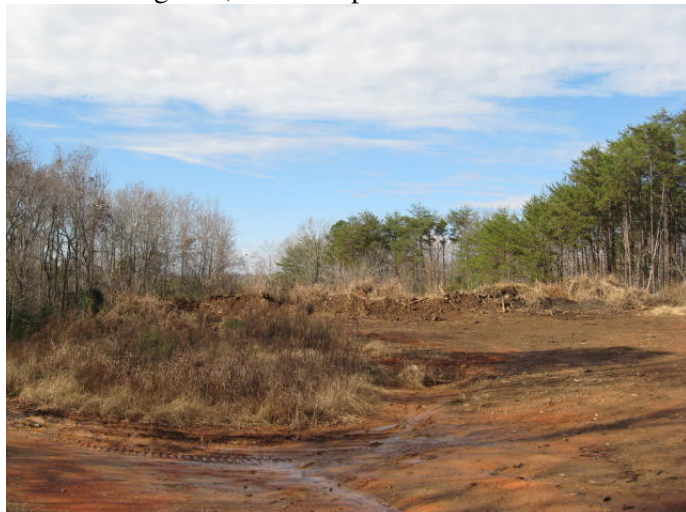
Soil screening area, soil stockpiled to be screened

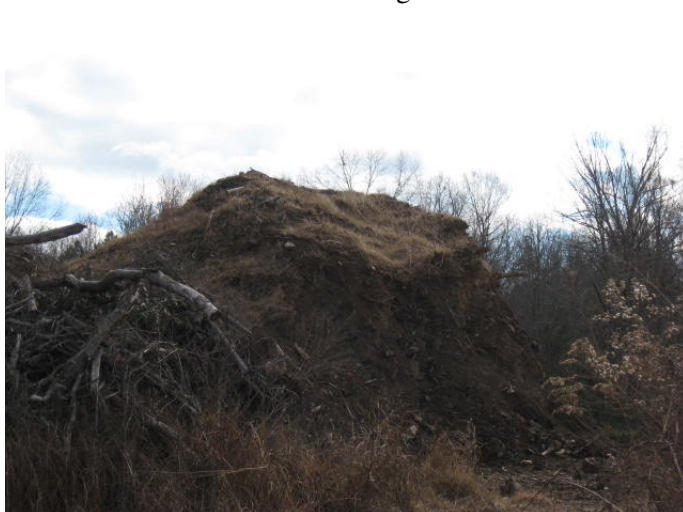
4. High carbon:nitrogen ratio material received is formed into piles resembling windrows. The windrows are left in-place, allowing vegetation to grow atop. Material is stored for ~ 18 months, turned ~ 3 times. Soil is collected from the windrows, during the turning operation, and is stored in piles until screened. Land clearing debris is ground twice a year or until enough is obtained to necessitate grinding.

Pile of soil obtained from turning LCD windrows

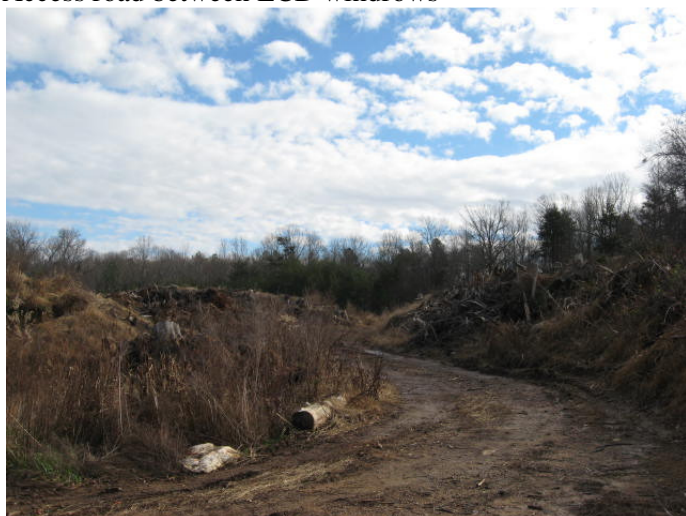
12. The LCD storage area piles appeared to be \leq 33 feet wide and 16 feet high.
13. The LCD storage area shall maintain \geq 20 feet row aisles.
14. Mulch piles should be limited to ~ 10 feet wide and 12 feet high.

Access road between LCD windrows

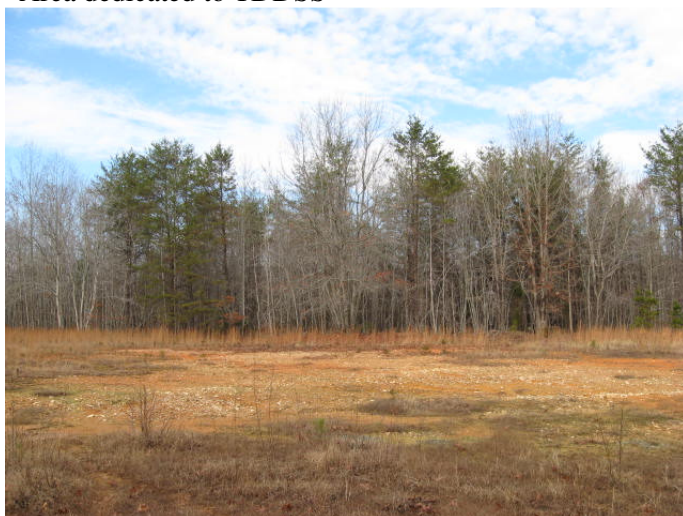
11. Mr. Scott agreed that the area designated for the TDDSS consists of ~ 2.4 acres cleared of woody vegetation and ~ 2.4 acres containing trees. It was suggested that the remaining area available for the TDDSS be cleared of trees to increase the area available for debris storage during a natural disaster.

Area dedicated to TDDSS
